Monitoring Report South Fork of Quitchupah Creek

Wed, Sep 24, 2014 at 1:40 PM

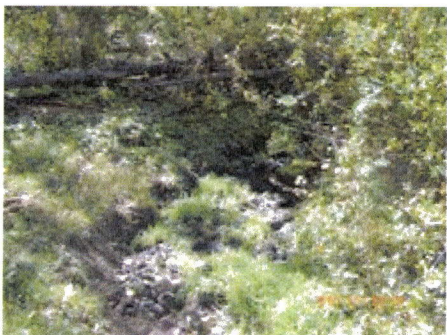
IMGP4234.JPG
1920K

During the two week period (Sept 8 – 21) the canyon was walked to look for new subsidence cracks, no cracks were found. Flow was observed to be similar in the channel above the road culvert and below the road at all photo point locations. Although the ponds being monitored were all observed to be dry on September 18th, cattle were laying and grazing around them. The springs associated with the So. Fork of Quitchupah drainage were observed to be flowing (imgp 4234).

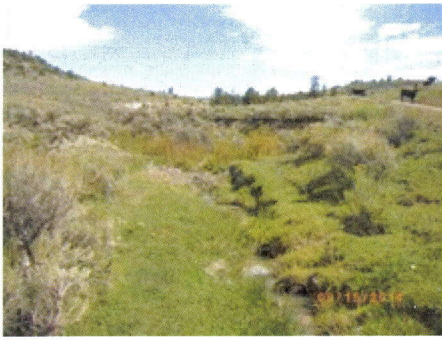
IMGP4237.JPG
1846K

On September 9th the flow in the South Fork of Quitchupah Creek was estimated at 90 gpm, on Sept. 15 the flow was estimated at slightly over 100 gpm (imgp 4237, 4245). Approximately 1.3 inches of rain fell at the mine site during the two week period. Muddy Creek where it crosses Highway 10 was observed to be sediment laden and close to flooding it's banks on the afternoon of Sept. 19.
